**Flood Control Project Maintenance
Levee Inspections**

Fall 2018 Levee Maintenance Deficiency Summary Report

Sacramento River Basin

City of Sacramento

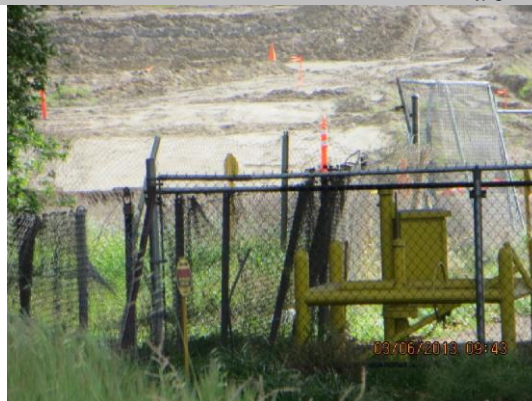
Photo 2 of 3 : UCIP_FA_2018_49955_33805.jpg

View of multiple markers indicating gas alignment.

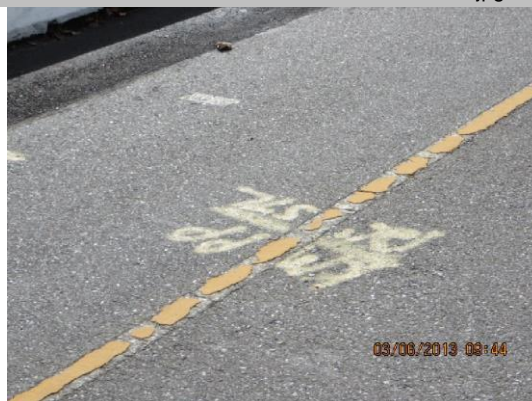
Photo 3 of 3 : UCIP_FA_2018_49955_33807.jpg

Comment Code						
Inspector Comment						
FS_ID:49955 DS_ID:21559 EP_NO: 14527 Repair Type: Non-Urgent Crossing Status: Found UCIP Comments: 07/21/2016 Meet with City of Sacramento North Area Drainage representatives: Mick Smith and Mike Gonsalves. LMA has been coordinating with owner and according to their records this pipe is a PG&E line. PG&E contact is Don Triplet and can be reached at 1-559-493-8007 or by email at DxTb@pge.com. LMA is working with the CVFPB to obtain status information. (DWR UCIP – O. Magana) 7/19/2016 Paddle marker missing from WS--owner will need to work with CVFPB to determine if paddle marker on WS is necessary. (DWR UCIP - omagana)3/22/2016 Need to contact owner to determine condition of crossing and last inspection date. (DWR UCIP - omagana) FIELD_STRUCT_DESC: 12.75-inch steel gas line through levee (right bank), unable to confirm depth below the crown. Permit indicates the pipeline shall be buried with a minimum cover of 1 feet in the levee slopes and 2 feet through the levee crown. Line was directionally bored under the left bank levee and low water channel at a minimum cover of 44 feet and 21 feet, respectively. Paddle marker located approximately 150 feet from levee crown on landside (LS). (12.75-inch line authorized under Permit No. 14527, 1987 - Southern Pacific Pipelines, Inc.) [Additional Reference(s): DWR Levee Log, 1993] FS Date: 7/19/2016

Underground service alert (USA) markings indicate 12 inch crossing through levee.

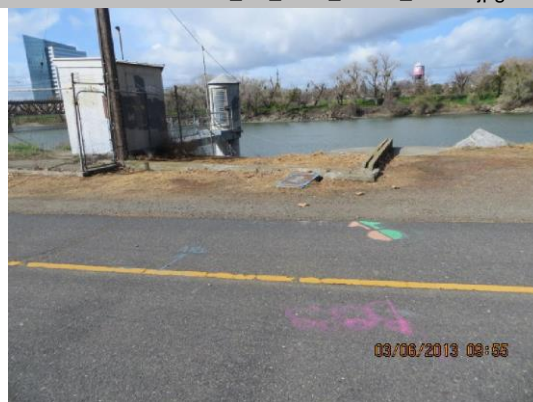
Photo 2 of 3 : UCIP_FA_2018_41414_72621.jpg

Underground Service Alert (USA) markings indicating 42 inch line through levee.

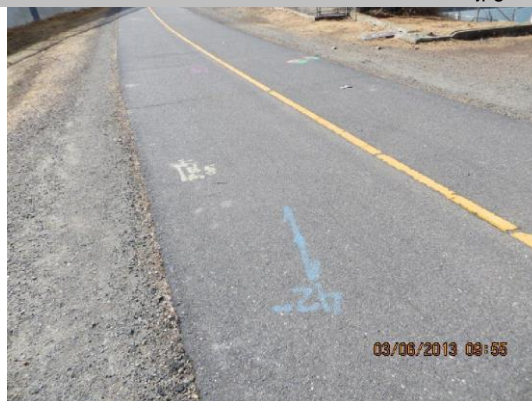
Photo 3 of 3 : UCIP_FA_2018_41414_72620.jpg

Comment Code						
Inspector Comment						
FS_ID:41414 DS_ID:24882 EP_NO: N/A Repair Type: Non-Urgent Crossing Status: Indicator Found UCIP Comments: 07/21/2016 Meet with City of Sacramento North Area Drainage representatives: Mick Smith and Mike Gonsalves. LMA engineer is investigating how to conduct inspection and defining levee toe. Crossing installed in the 1930s according to LMA engineer and not 1966.(DWR UCIP - O. Magana) 03/06/2013 Need to contact owner to determine status of crossing. No permit found during desk study review. (DWR UCIP - O. Magana) FIELD_STRUCT_DESC: 42-inch water transmission main of unknown material through levee at unknown depth. Crossing installed in 1966. Crossing installed in the 1930s according to LMA engineer and not 1966. FS Date: 3/6/2013

View of alignment along levee.

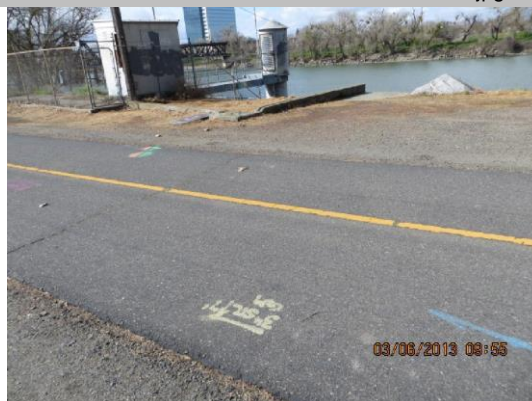
Photo 1 of 2 : UCIP_FA_2018_41415_72630.jpg

Comment Code					
Inspector Comment					
FS_ID:41415 DS_ID:24883 EP_NO: N/A Repair Type: Non-Urgent Crossing Status: Indicator Found UCIP Comments: 07/21/2016 Meet with City of Sacramento North Area Drainage representatives: Mick Smith and Mike Gonsalves. No Additional information was made available regarding the fate of this crossing. (DWR UCIP – O. Magana) 03/06/2013 Need to contact owner to confirm alignment and status of crossings. No permit found during desk study review. (DWR UCIP - O. Magana) FIELD_STRUCT_DESC: ARV communication line and 3-inch steel communication line through levee at unknown depth below the levee crown. FS Date: 3/6/2013

Underground Service Alert (USA) markers visible on levee crown.

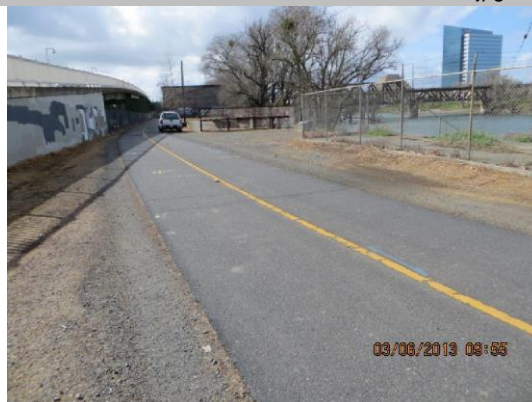
Photo 2 of 2 : UCIP_FA_2018_41415_72623.jpg

Overview of levee crown looking downstream.

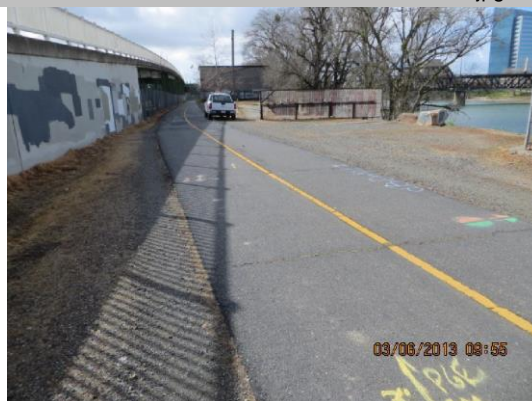
Photo 1 of 3 : UCIP_FA_2018_52599_72627.jpg

FS_ID:52599
DS_ID:24884
EP_NO: N/A
Repair Type: Non-Urgent
Crossing Status: Indicator Found

UCIP Comments: 08/11/2017 Received supporting documentation from PG&E regarding the status of the line and the line is still in use. PG&E has conducted various inspections and monitoring activities in 2012 and 2016 to determine the condition of the line and no issues were identified by PG&E for this line. PG&E is currently conducting a leak survey of this area as of August 2, 2017 since the last leak survey for this area was conducted in October 2012. Based on the supporting documentation provided by PG&E this crossing has been downgraded from Urgent to Non-Urgent, once PG&E provides results of the August 2, 2017 leak test this crossing can re-evaluated. No permit was provided by PG&E. (DWR UCIP - O. Magana)

10/17/2014 No markers found. Need to contact owner to determine status of crossing and to determine last inspection date. (DWR UCIP - omagana)

View of levee crown and alignment of PG&E line visible by yellow paint markings.

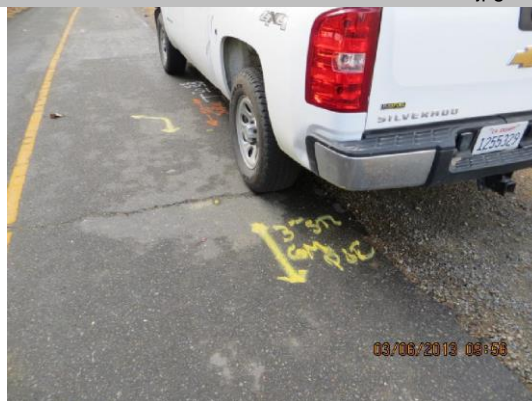
Photo 2 of 3 : UCIP_FA_2018_52599_72626.jpg

07/19/2016 same as previous inspection. Need to contact owner to determine status of crossing. Unable to confirm alignment or depth through the levee crown. (DWR UCIP - omagana)10/17/2014 No markers found. Need to contact owner to determine status of crossing and to determine last inspection date. (DWR UCIP - omagana)

Underground Service Alert (USA) markings of PG&E line through levee, Photo 1 of 2.

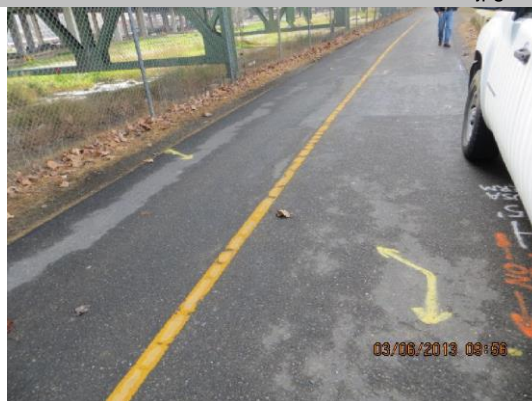
Photo 3 of 3 : UCIP_FA_2018_52599_72625.jpg

07/19/2016 same as previous inspection. Need to contact owner to determine status of crossing. Unable to confirm alignment or depth through the levee crown. (DWR UCIP - omagana)10/17/2014 No markers found. Need to contact owner to determine status of crossing and to determine last inspection date. (DWR UCIP - omagana)
FIELD_STRUCT_DESC: 3-inch steel gas line though levee at unknown depth. Underground alert service (USA) markings indicate this line is a PG&E line (USA markings visible in 2013). In case of an emergency related to this crossing PG&E has identified the following contact: PG&E's local pipeline engineer, Mike Aronoff, at (916) 307-9472 (cell) and Gas Control (North) 800-442-4743. For non-emergency issues please contact the local PG&E Gas Pipeline Operations & Maintenance (GPOM) Supervisors for the Sacramento region, David Wade at (209) 639-1039 (cell) or Ron Hicks at (916) 396-9038 (cell).

Underground Service Alert (USA) markings of PG&E line through levee,
Photo 2 of 2.

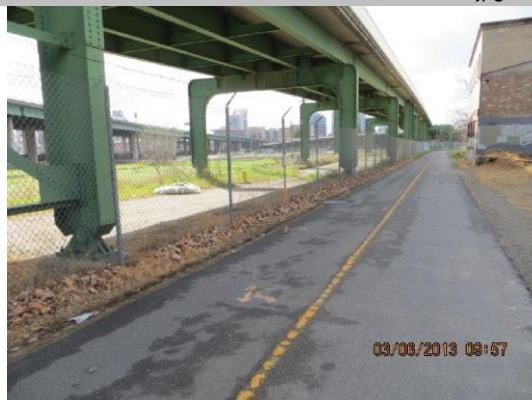
Photo 2 of 2 : UCIP_FA_2018_41416_72628.jpg

Comment Code						
Inspector Comment						
FS_ID:41416 DS_ID:24885 EP_NO: N/A Repair Type: Non-Urgent Crossing Status: Indicator Found UCIP Comments: 07/21/2016 Meet with City of Sacramento North Area Drainage representatives: Mick Smith and Mike Gonsalves. Crossing belongs to AT&T. AT&T contact is Astrid Willard Manager Public Works Director of State R/R and can be reached at 916-971-3961 or by email at astrid.willard@att.com. (DWR UCIP – O. Magana) 03/06/2013 No markers visible as per Title 23. Recommend having utility owner coordinate with Central Valley Flood Protection Board (CVFPB). (DWR UCIP - O. Magana) FIELD_STRUCT_DESC: ATT communication line through levee at unknown depth. FS Date: 3/6/2013

Alignment of communication line through levee, Photo 2 of 2.

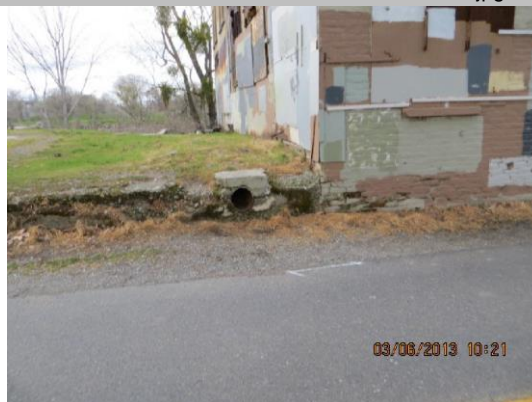
Photo 1 of 3 : UCIP_FA_2018_40848_72633.jpg

Comment Code					
Inspector Comment					
FS_ID:40848					
DS_ID:24887					
EP_NO: N/A					
Repair Type: Non-Urgent					
Crossing Status: Indicator Found					
UCIP Comments: 07/21/2016 Meet with City of Sacramento North Area					
Drainage representatives: Mick Smith and Mike Gonsalves. Pipe is					
installed above crown. (DWR UCIP – O. Magana)					
03/06/2013 Pump station appears non-functional. Owner will need to					
coordinate with DWR-Inspector and CVFPB to determine if crossing					
meets Title 23 requirements. (DWR UCIP - O. Magana)					
FIELD_STRUCT_DESC: 12-inch steel drainage pipe connected to 10					
inch pipe through levee at unknown depth.					
FS Date: 3/6/2013

Pipe through levee visible next to building located on levee.

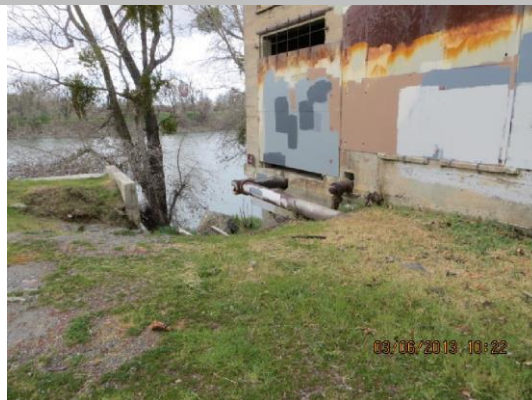
Photo 3 of 3 : UCIP_FA_2018_40848_72631.jpg

Comment Code						
Inspector Comment						
FS_ID:40848						
DS_ID:24887						
EP_NO: N/A						
Repair Type: Non-Urgent						
Crossing Status: Indicator Found						
UCIP Comments: 07/21/2016 Meet with City of Sacramento North Area						
Drainage representatives: Mick Smith and Mike Gonsalves. Pipe is						
installed above crown. (DWR UCIP – O. Magana)						
03/06/2013 Pump station appears non-functional. Owner will need to						
coordinate with DWR-Inspector and CVFPB to determine if crossing						
meets Title 23 requirements. (DWR UCIP - O. Magana)						
FIELD_STRUCT_DESC: 12-inch steel drainage pipe connected to 10						
inch pipe through levee at unknown depth.						
FS Date: 3/6/2013

View of building and additional concrete structures located on levee crown at waterward side.

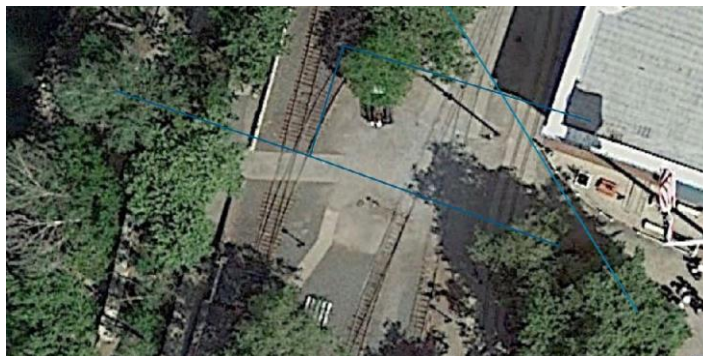
Photo 1 of 1 : UCIP_FA_2018_41247_72740.jpg

FS_ID:41247
DS_ID:24889
EP_NO: N/A
Repair Type: Non-Urgent
Crossing Status: Indicator Found
UCIP Comments: 06/06/2017 Received documentation from the City of Sacramento indicating that this crossing was internally inspected on 10/31/2013, PACP Sewer Report was provided. PACP report is missing rating evaluation. No additional information was received from the City of Sacramento. Need to request evaluation of pipe (integrity of pipe section through the levee) and find out when the City is planning the next internal inspection for this pipe. (DWR UCIP – O. Magana)
07/21/2016 Meet with City of Sacramento North Area Drainage representatives: Mick Smith and Mike Gonsalves. No Additional information was made available through the LMA. (DWR UCIP – O. Magana)
03/06/2013 Unable to confirm if crossing exists. Approximate alignment provided by the City of Sacramento. Need to confirm alignment and status of crossing.

Alignment provided by City of Sacramento of 10 inch line--not found during field inspection.

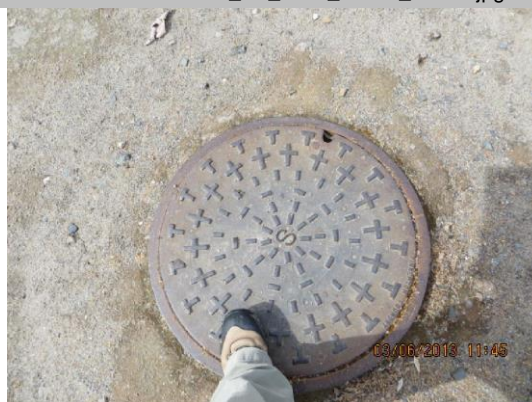
Photo 2 of 3 : UCIP_FA_2018_20384_34409.jpg

Comment Code					
Inspector Comment					
FS_ID:20384 DS_ID:21561 EP_NO: N/A Repair Type: Non-Urgent Crossing Status: Indicator Found UCIP Comments: 07/21/2016 Meet with City of Sacramento North Area Drainage representatives: Mick Smith and Mike Gonsalves. Internal inspection expected in August 2016 by the City of Sacramento. (DWR UCIP – O. Magana) 03/06/2013 Only manhole was visible; need to determine condition of crossing; Will need to follow up with the City of Sacramento. (DWR UCIP - O. Magana) FIELD_STRUCT_DESC: 18-inch drainage pipe of unknown material through the levee, 5 feet below the levee crown. Concrete surge box on the waterside (WS) of the retaining wall. Concrete box spillway. [Additional Reference(s): DWR Levee Log, 1993] FS Date: 3/6/2013

View of manhole located at the edge of waterward.

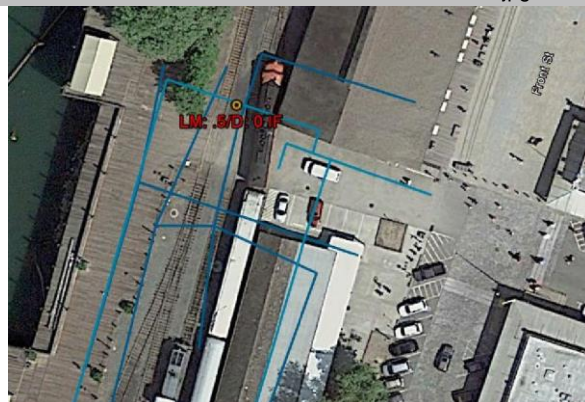
Photo 1 of 1 : UCIP_FA_2018_41418_72741.jpg

Aproximate alignment provided by City of Sacramento -- unable to confirm if crossing is active.

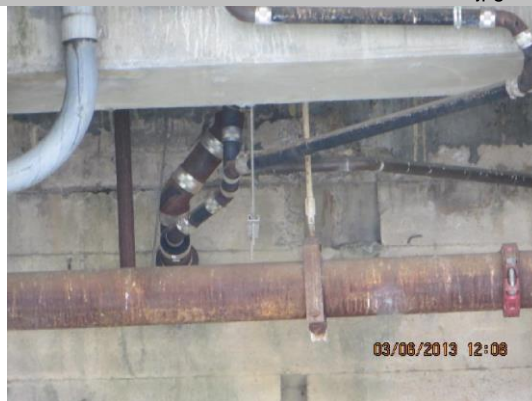
Photo 1 of 1 : UCIP_FA_2018_41260_72743.jpg

Conduit through floodwall.

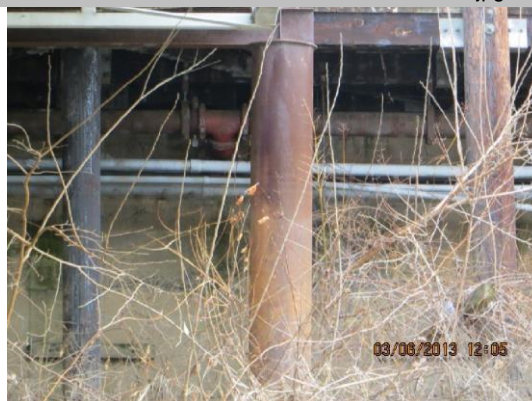
Photo 1 of 1 : UCIP_FA_2018_41263_72744.jpg

Pipe through floodwall.

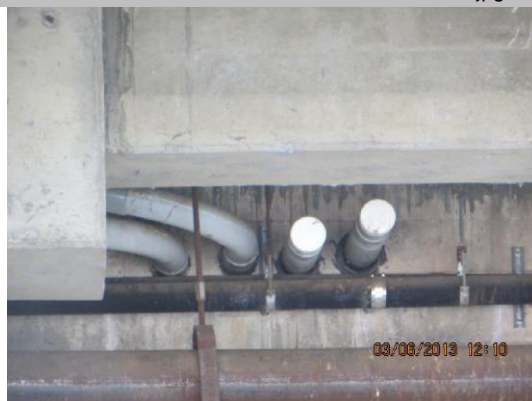
Photo 1 of 1 : UCIP_FA_2018_41420_72746.jpg

View of conduits through floodwall visible from waterward side.

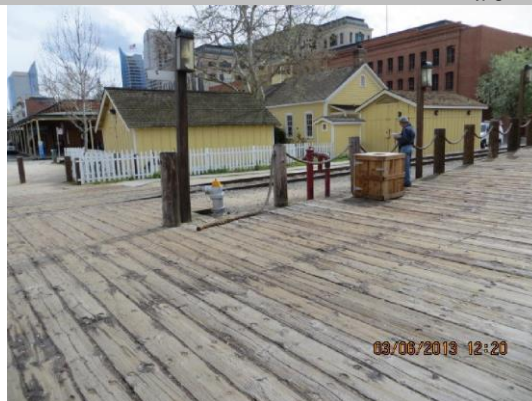
Photo 1 of 1 : UCIP_FA_2018_41266_72747.jpg

Fire hydrant visible on levee crown.

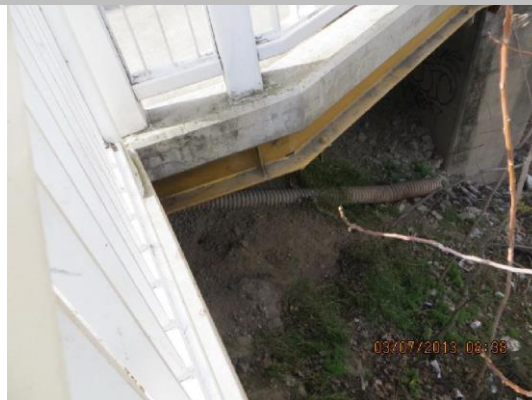
Photo 2 of 3 : UCIP_FA_2018_41421_72749.jpg

Pipe visible on waterward side.

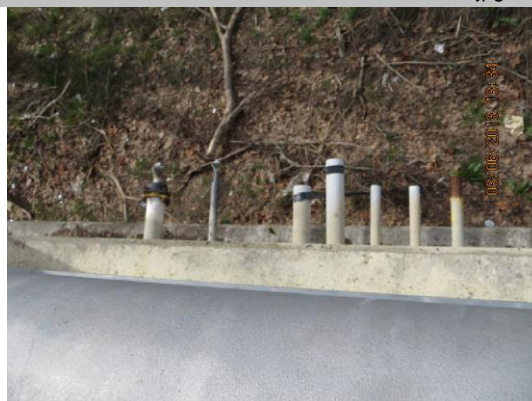
Photo 2 of 3 : UCIP_FA_2018_41422_72753.jpg

Conduits through floodwayll.

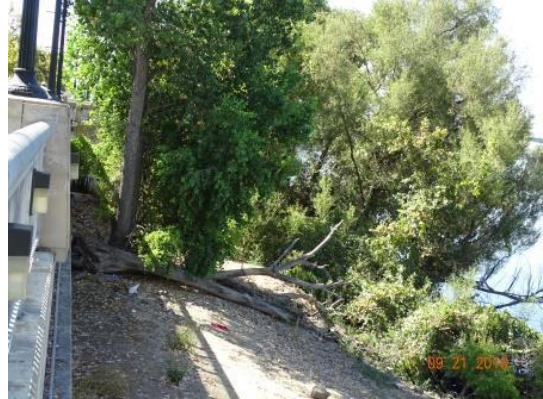
Photo 1 of 1 : FA_2018_NA0005_251_83_20180927_00113.jpg

Tree debris against floodwall. Fall 2018

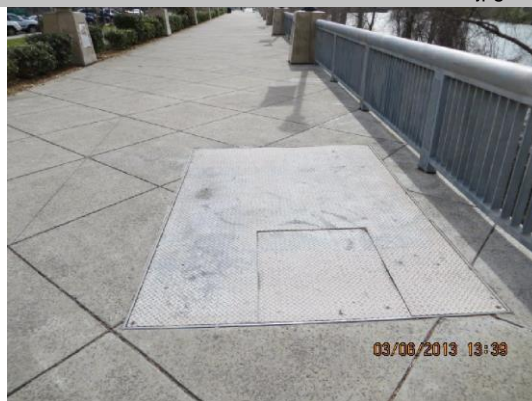
Photo 2 of 3 : UCIP_FA_2018_52601_34413.jpg

Valve box located along walkway on levee crown.

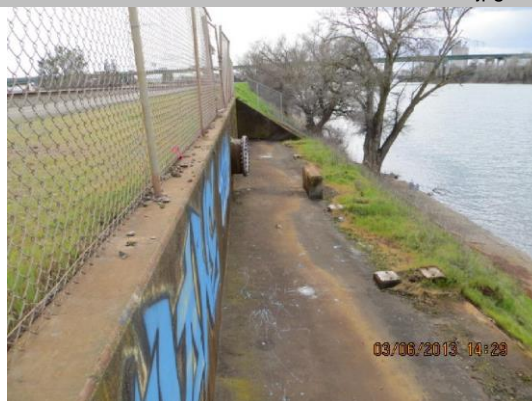
Photo 2 of 3 : UCIP_FA_2018_41425_34144.jpg

Headwall with 1 crossing capped off.

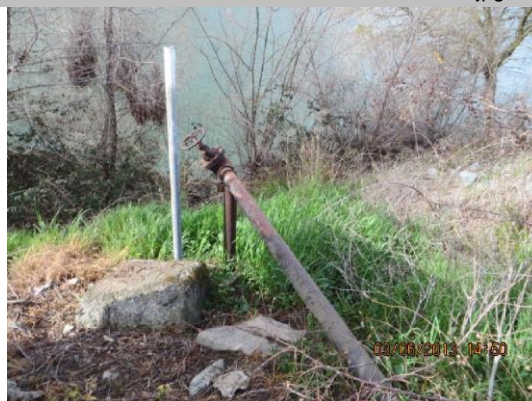
Photo 2 of 2 : UCIP_FA_2018_49767_34066.jpg

View of pipe and gate valve located on waterward slope.

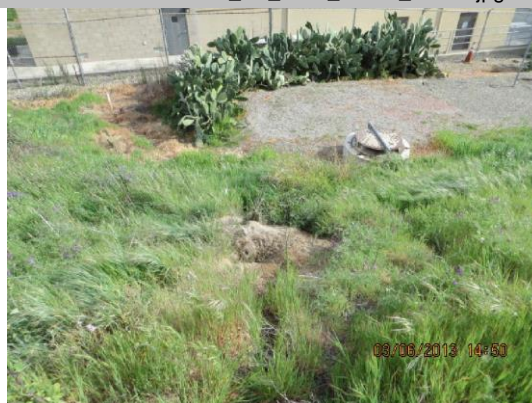
Photo 2 of 3 : UCIP_FA_2018_49957_34072.jpg

View of landward side--tall grass along slope limit inspection.

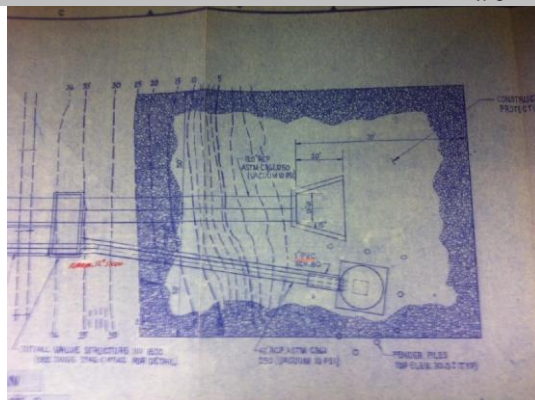
Photo 2 of 3 : UCIP_FA_2018_49778_34027.jpg

Rip rap protection around outfall structure for 42-inch and 120-inch pipes.

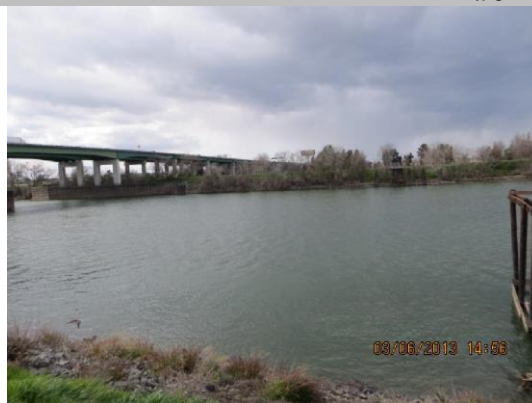
Photo 2 of 3 : UCIP_FA_2018_49958_34050.jpg

View of waterward side--outlet submerged.

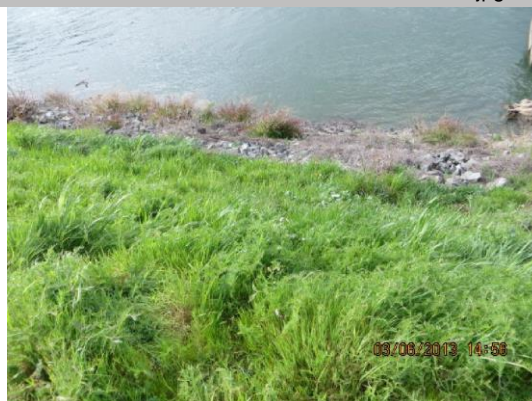
Photo 3 of 3 : UCIP_FA_2018_49958_34049.jpg

Tall grass along pipe alignment--limited inspection.

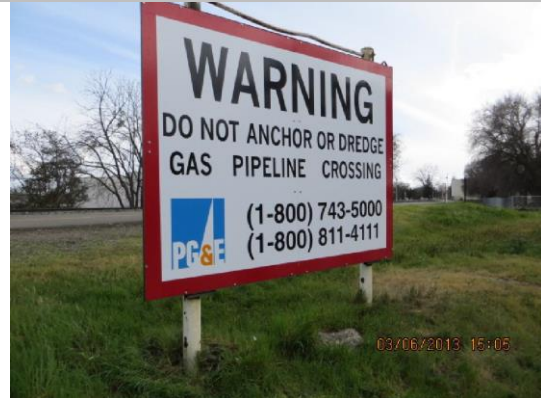
Photo 1 of 3 : UCIP_FA_2018_32883_59502.jpg

PG&E warning gas line crossing--waterward side view.

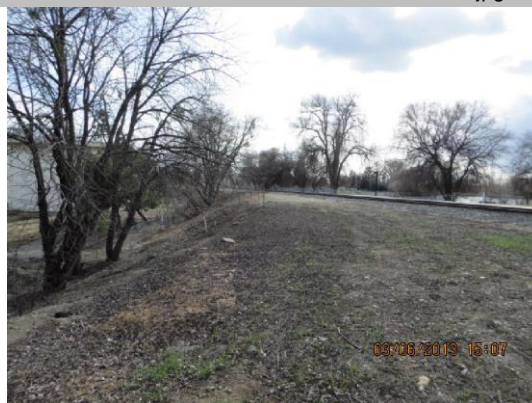
Photo 1 of 3 : UCIP_FA_2018_41442_59560.jpg

View of crossing approximately 110 feet downstream--stand pipes located on landward shoulder.

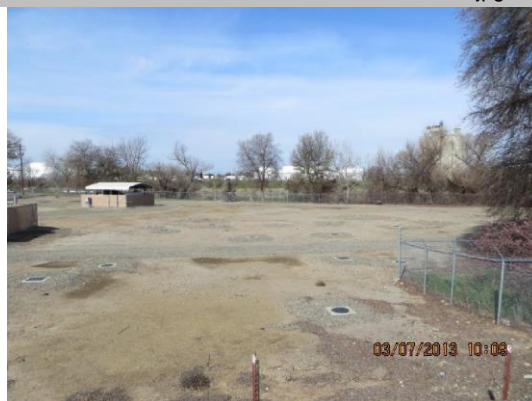
Photo 3 of 3 : UCIP_FA_2018_41282_59573.jpg

More vapor wells present on levee crown.

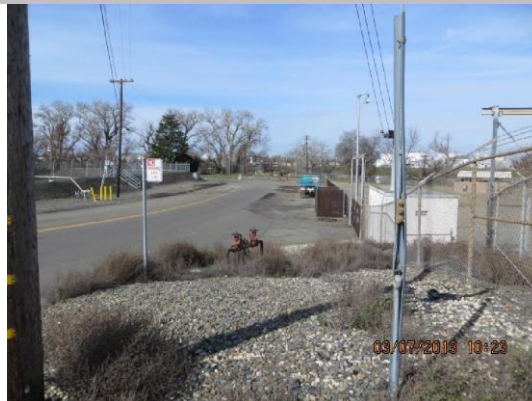
Photo 2 of 3 : UCIP_FA_2018_41427_59506.jpg

Backflow prevention device on shoulder.

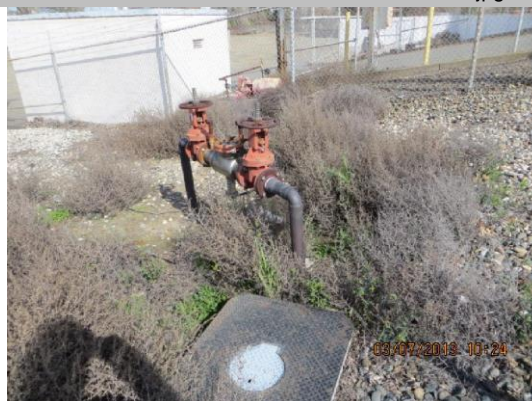
Photo 3 of 3 : UCIP_FA_2018_41427_59505.jpg

Close up of positive closure device.

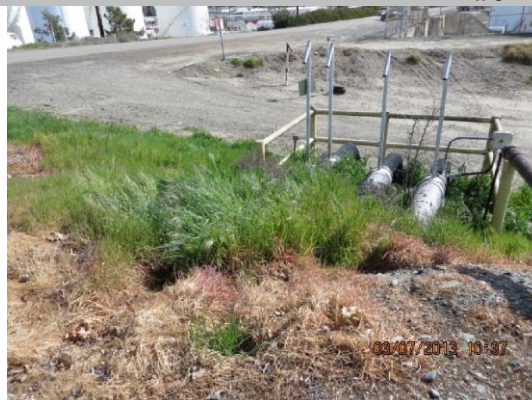
Photo 2 of 3 : UCIP_FA_2018_41452_59524.jpg

Dense burrow activity along landward slope.

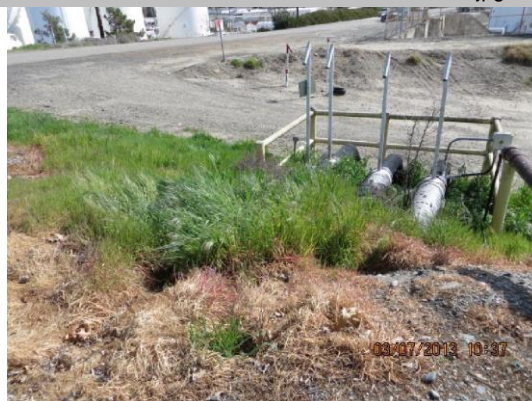
Photo 3 of 3 : UCIP_FA_2018_41448_59512.jpg

Dense vegetation and large burrow holes located on shoulder.

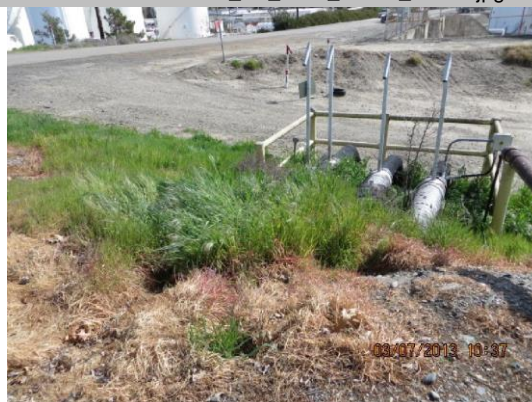
Photo 2 of 3 : UCIP_FA_2018_48322_59520.jpg

Dense burrow activity along levee slope.

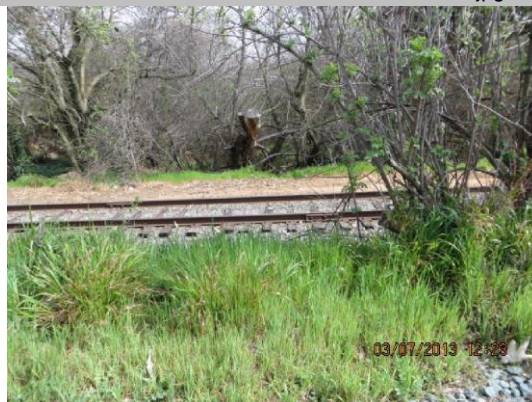
Photo 2 of 2 : UCIP_FA_2018_41295_72763.jpg

Dense vegetation along landward slope.

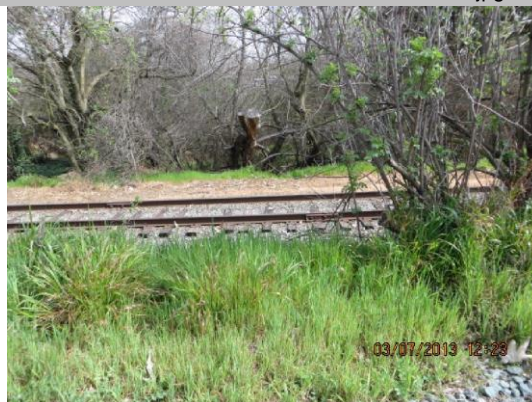
Photo 2 of 2 : UCIP_FA_2018_38827_72765.jpg

Dense vegetation on landward side.

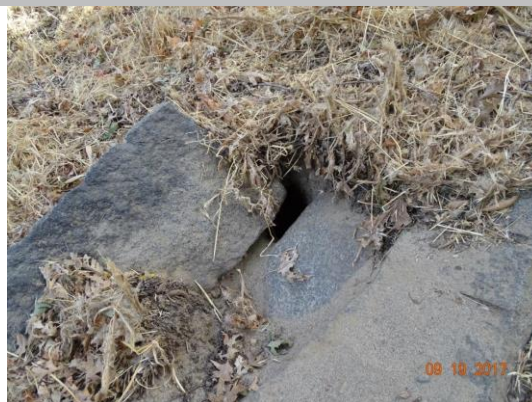
Photo 1 of 1 : FA_2018_NA0005_251_82_20180917_00012.jpg

View of rodent hole on waterside slope. Fall 2017.

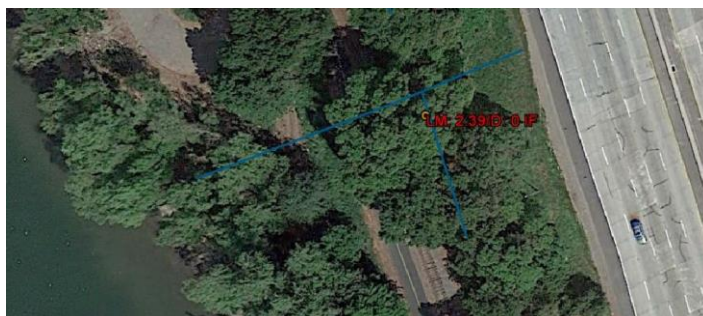
Photo 1 of 1 : UCIP_FA_2018_41433_72801.jpg

Approximate alignment for crossing provided by City of Sacramento GIS.

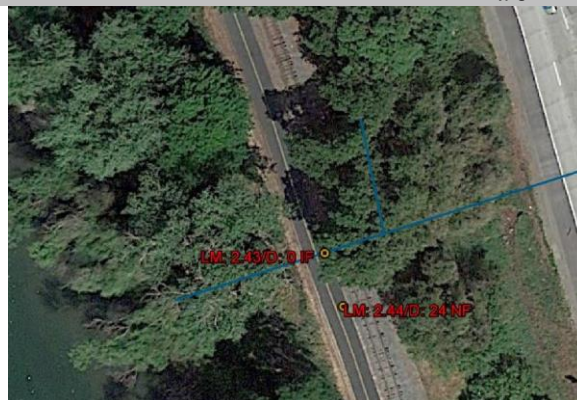
Photo 1 of 1 : UCIP_FA_2018_41296_72767.jpg

Approximate alignment of crossing provided by the City of Sacramento.
